FAILURE ANALYSIS OF PIPELINE COATINGS

INVESTIGATING THE ROOT CAUSES TO IMPROVE
PERFORMANCE AND BUILD A SAFER ENVIRONMENT

Failure analysis of a transmission and distribution pipeline coating.

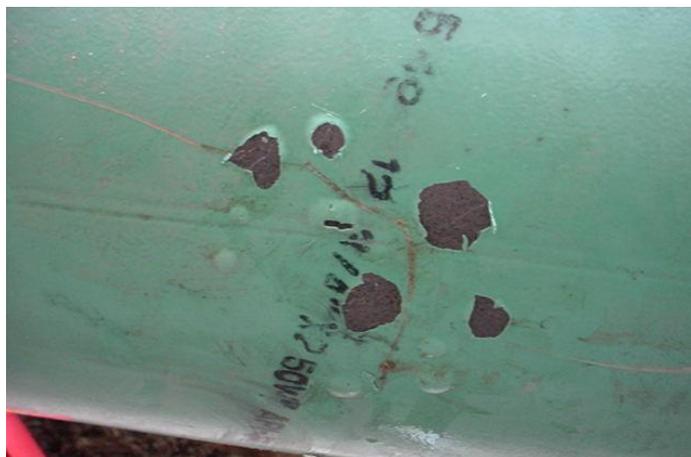
This case study involves a 12-inch diameter Fusion Bonded Epoxy (FBE) coated steel pipe that carried natural gas for residential service and was under cathodic protection while in service. The pipe showed blistering of the FBE coating and corrosion in the pipe (Figure 1-2-3). Standard failure analysis techniques were applied to determine the primary causes of the blistering. A determination of detrimental effects to the pipe wall was conducted as well.

Figure 1: blistering of FBE coating on steel pipe

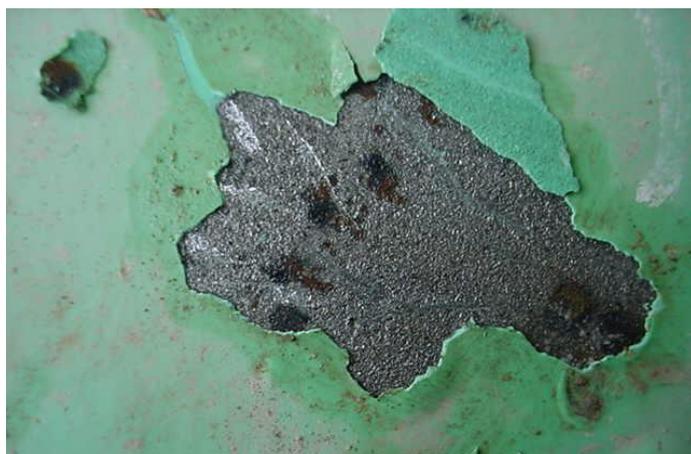
Figure 2: blistering of FBE coating on steel pipe

Based on testing and analysis, it was determined that the blistering of the Fusion Bonded Epoxy (FBE) coated steel pipe was due to surface contamination of the pipe prior to or during the coating application.

The pipe should be recoated in areas where general de-lamination of the coating is observed. This is to avoid localized corrosion of the pipe in the event there is lack of protection, inadequate cathodic protection, or shielding effects due to areas where the epoxy coating has a much higher thickness than 12 mils.

Blister formation and FBE de-lamination can be controlled through appropriate application of the FBE coating by being extremely careful in cleaning the substrate of all contaminants, and implementing a quality control program to ensure there are no contaminants present on the substrate prior to the coating application.

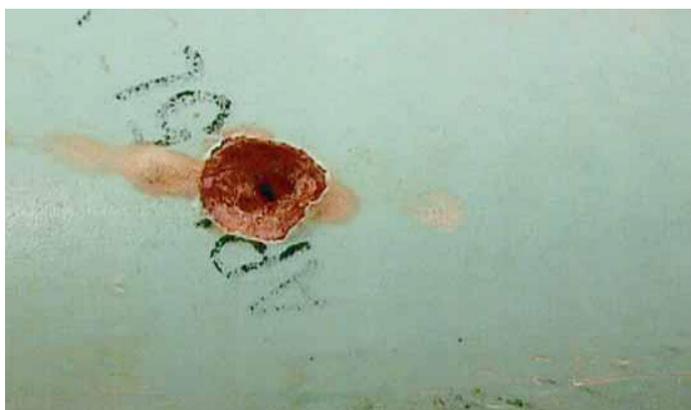
Figure 3: evidence of corrosion on the FBE coated steel pipe

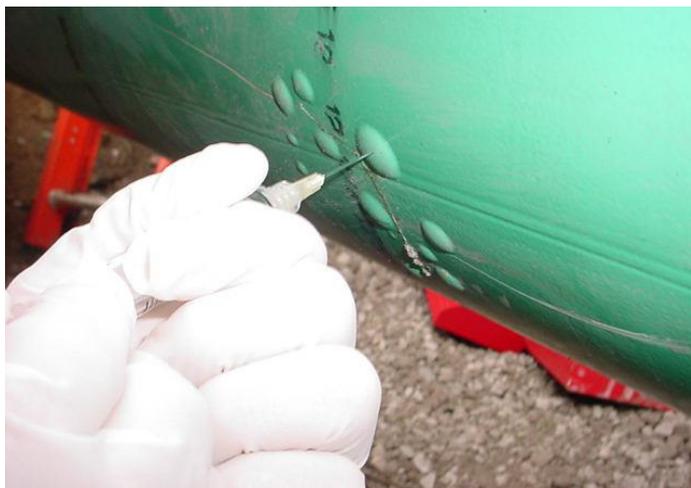
Figure 4: liquid extracted from the blisters.

As shown in Figure 4, a hypodermic syringe was used to extract liquid from inside two blisters during the on-site investigation for subsequent laboratory analysis. The liquid samples were analyzed to reveal their chemical analysis and determine if they were harmful to the carbon steel pipe.

The large amounts of nitrates (614 parts per million to 0.16%) and sodium (1.16 to 1.62%) were significant because they usually do not permeate through the coating readily, which means they were present prior to the application of the coating. Water and oxygen will permeate through the coating and combine with the sodium to create sodium hydroxide.
